**Daily Update**  
April 14

Devil's Slide (post mile 39.14)

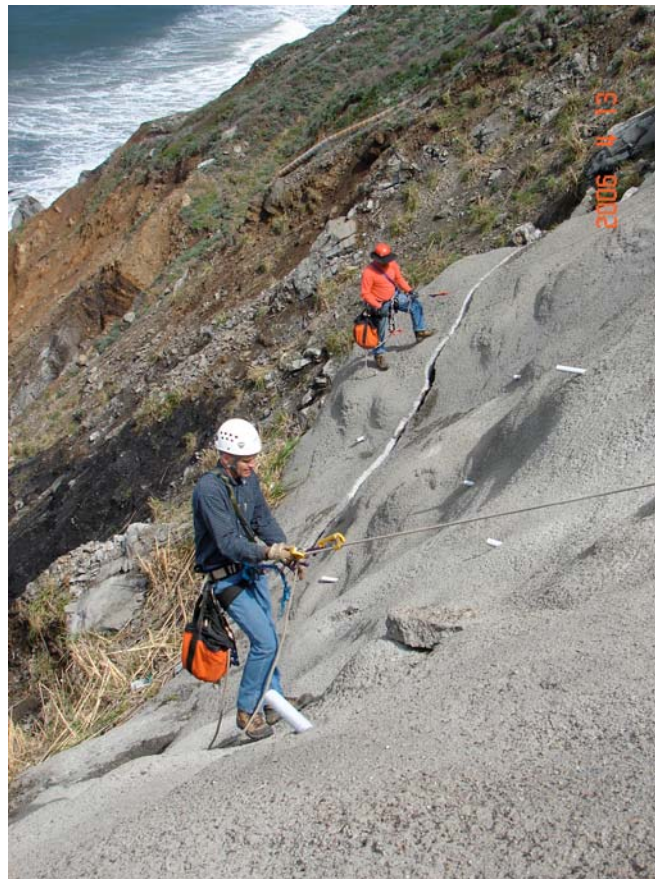
- Geologists determined that the area below the rock face is still too dangerous for drilling operations to continue. The plan to remove loose material on the cliff above the road is complete. Work will start Monday morning 4/17/06.

Geologists rappel down the cliff at Devil's Slide to assess slide conditions. A crack is clearly visible just above where the man in the red jacket is standing.

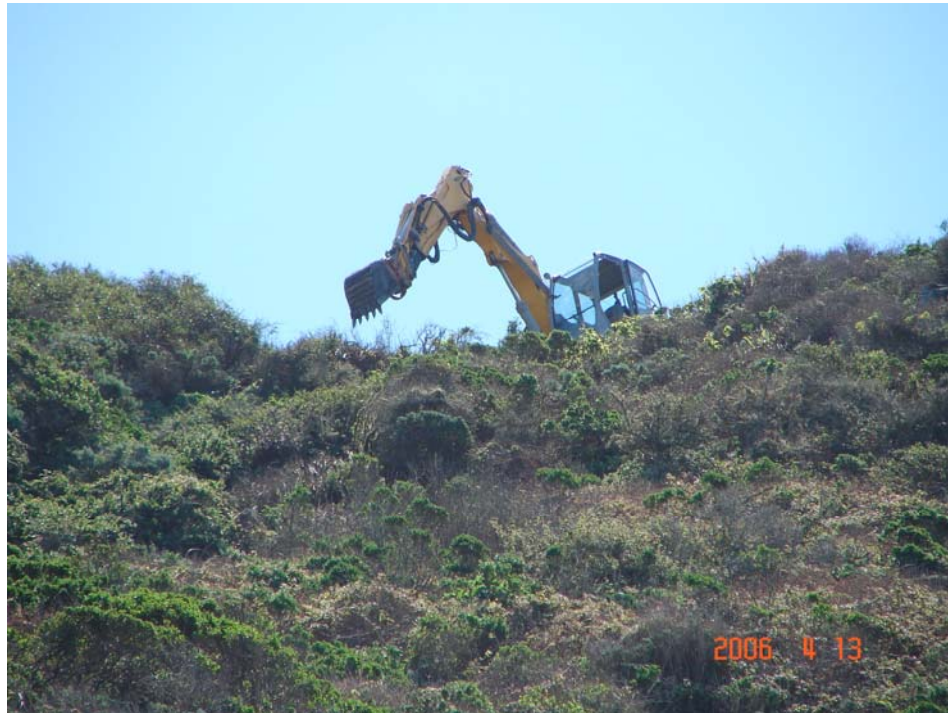
- Preliminary work to build a temporary access road and staging area at the top of the cliff started today.

The "spider" machine begins work at the top of the cliff overlooking the road at Devil's Slide.
